**TECHNICAL NOTE 2299**

EXPOSURE TESTS OF GALVANIZED-STEEL-STITCHED  
ALUMINUM ALLOYS

By Fred M. Reinhart

National Bureau of Standards

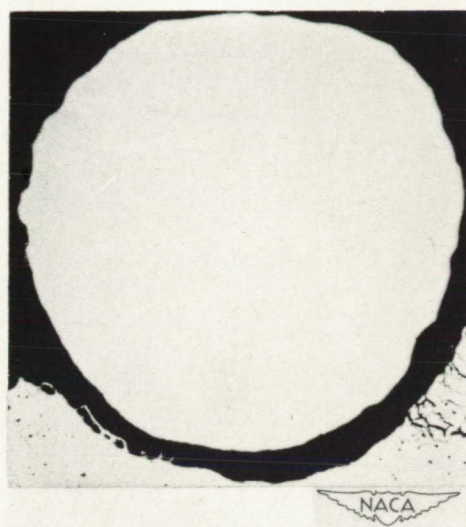
24S-T3 panels.- After 2 months of exposure there was no evidence of rusting but there were white corrosion products on the zinc coatings of the steel wires used to staple the 24S-T3 panels. These zinc coatings disappeared entirely after 6 months of exposure and the staples were covered with a dark adherent rust (fig. 1). Examination of cross sections of the staple wires showed that they were pitted (fig. 2).

Figure 2.- Pitting on zinc-coated steel wires on 24S-T3 panels after 6 months of exposure in the tidewater. X50.

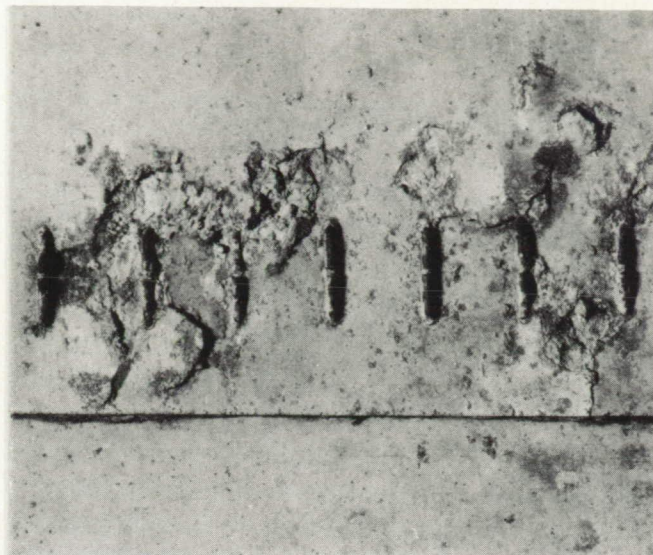
The condition of the staples and the 24S-T3 sheets after 37 months of exposure in the tidewater is shown in figures 6 and 7. The staples were much more rusted and pitted than those after 6 months of exposure.

(Compare figs. 2 and 8.) Crevice corrosion had not only penetrated the sheet but also the accumulation of corrosion products had built up sufficient pressure to cause the sheets to fracture (fig. 6).

Figure 6.- Stapled portion of 24S-T3 panel after 37 months of exposure in the tidewater. Zinc coatings are gone from the staples and crevice corrosion which started at faying surfaces of lap joint has penetrated sheet. The sheet also is exfoliated. Actual size.

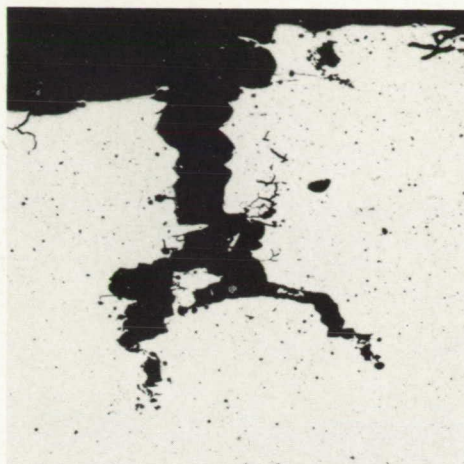
Stress-corrosion cracks were also present on the 24S-T3 sheets underneath the staples after 10, 22, and 37 months of exposure, examples of which are shown in figures 9 and 10 after 37 months of exposure. These cracks also had their origins on the tension or faying-surface sides of the sheets. Typical intergranular corrosion also is shown in figure 10.

Figure 9.- Stress-corrosion crack in 24S-T3 which originated at faying surface of sheet opposite staple after 37 months of exposure in tidewater. X100.

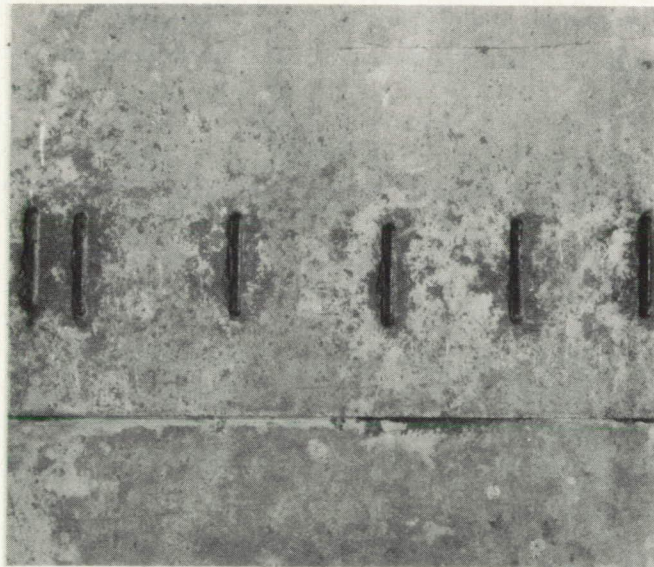
The staples in the alclad 24S-T3 panel were still a dark grayish red in color after 37 months of exposure, indicating that some of the zinc-iron alloying layers were still present (figs. 12 and 13). This observation was substantiated by microscopic examinations of cross sections of the staples which showed that they were just beginning to pit (fig. 14).

Figure 12.- Stapled portion of alclad 24S-T3 panel after 37 months of exposure in the tidewater. Tops of staples are a dark grayish red, indicating that some of the zinc-iron alloy layer is still present. Actual size.

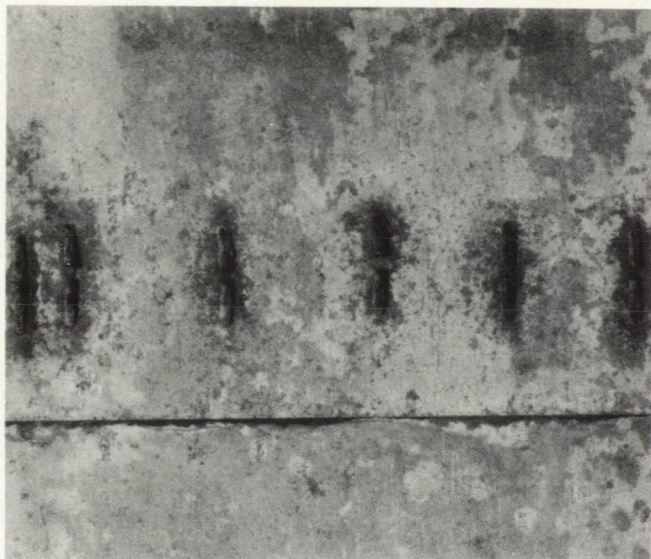
Figure 13.- Opposite side of panel shown in figure 12. There is still considerable gray color on much of the area of the staples. Actual size.

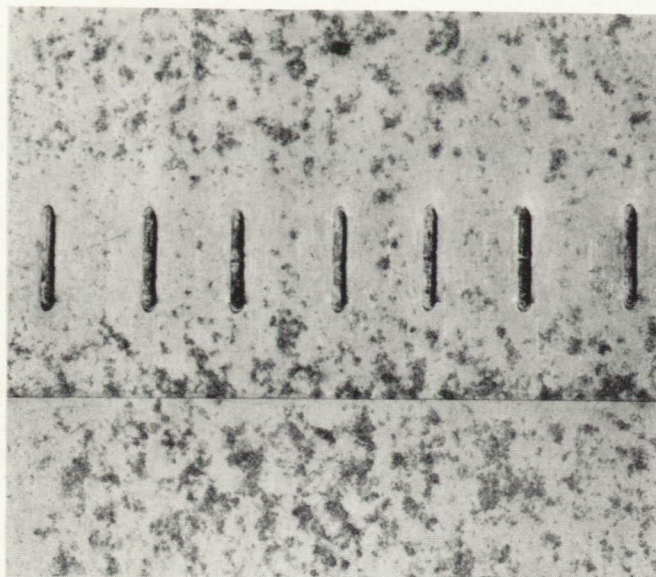
The galvanized staples on both the 24S-T3 and the alclad 24S-T3 panels were still coated with gray corrosion products after 37 months of exposure in the marine atmosphere, indicating that zinc or zinc-iron alloy layers were still present (figs. 16 to 19). There were a few places where the staples had darkened but none where red rust was detected.

Figure 19.- Earthward surface of same panel as in figure 18. Portions of some staples were blackish gray, indicating that the zinc-iron alloy layer was exposed (second staple from the right). Actual size.
